'There is always another way to destroy refractories!' Root cause analysis of a steel ladle argon system breakout

By Tom Vert

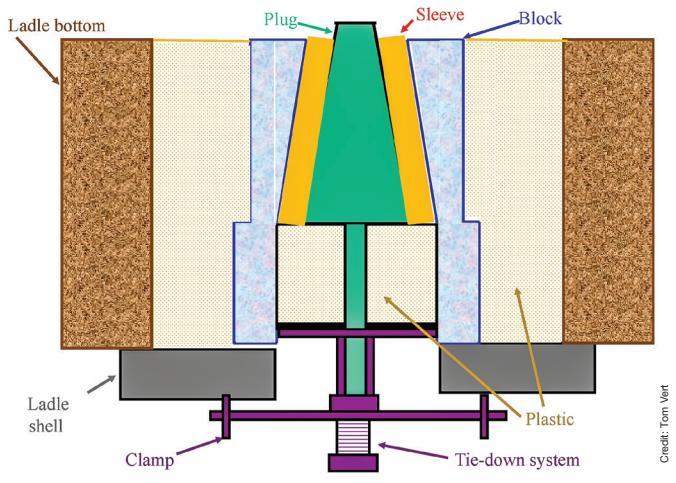
Figure 1. Typical argon stirring system layout.

In a direct stirring system (Figure 1), argon is injected through a piping system into the bottom of the steel ladle. The argon plugs are made of a permeable refractory that allows the gas to flow at the rate necessary for good stirring. Over time, the plugs will wear down and must be replaced with new ones, typically after 10–20 uses. Sometimes, the wear is accelerated and/or the plugs are not replaced at the right moment. In that case, the 20–350 tons of molten steel may break out from the ladle and escape, resulting in damages to major equipment (Figure 2).

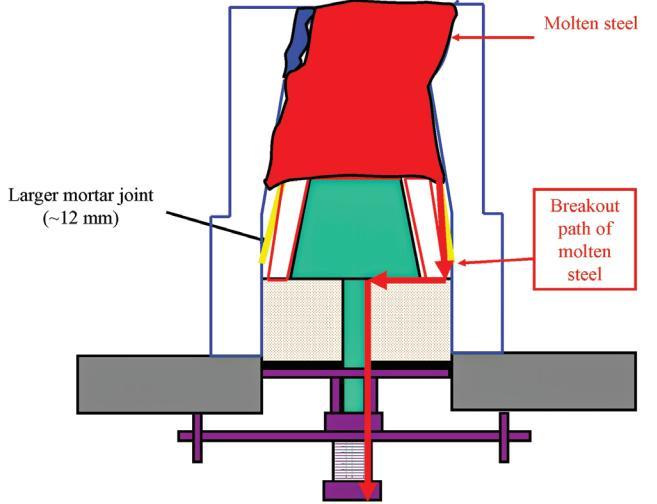
Figure 2. An illustration showing one pathway that molten steel can take during a breakout event.

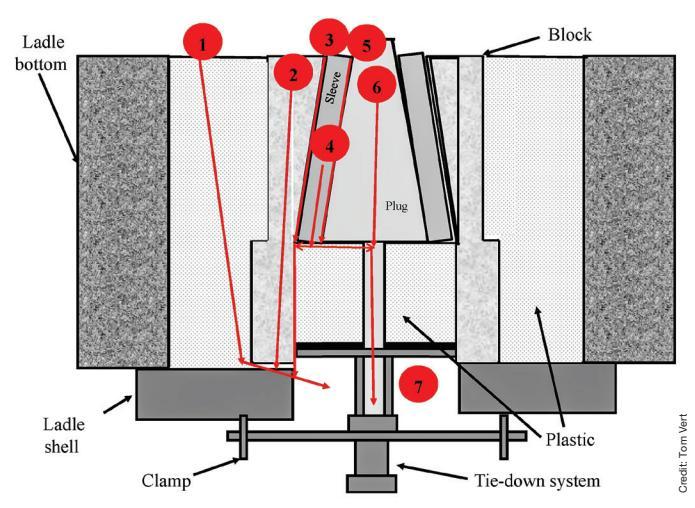
Figure 3. Seven main failure modes through which molten steel escapes in a direct stirring system: 1) plastic refractory joint, 2) refractory surround block, 3) joint between block and sleeve, 4) sleeve itself (and supporting plastic), 5) joint between the sleeve and plug, 6) argon plug itself (and supporting plastic), and 7) argon plug itself and piping system.

Figure 3 shows the seven main failure modes through which molten steel escapes the ladle during a breakout event. Failure modes 1, 2, and 3 usually can be determined by the physical evidence of deteriorated refractories and/or steel skulls left over from the breakout. In contrast, failure modes 4, 5, 6, and 7 can be harder to find, and so require a review of the following key evidence:
